Use the synergy of telediagnosis

telediagnose.com magazine now always industry-specific

Housing crack on a bucket-wheel excavator

Online vibration diagnosis and load monitoring on bucket-wheel excavators

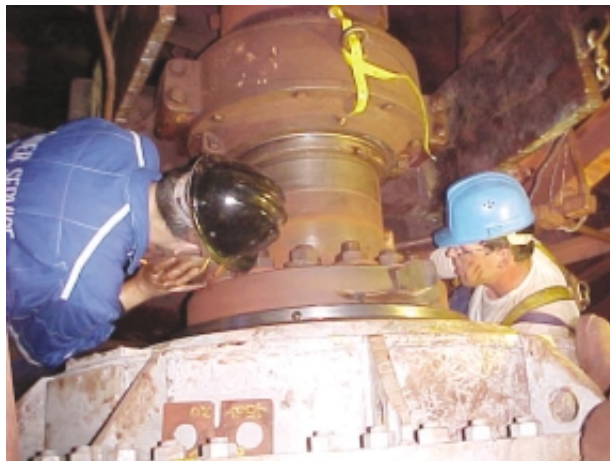
But one step at a time: Bucket-wheel excavators are being used around the world for strip mining and material moving technology to continuously excavate and load material and bulk goods. In bucket-wheel excavators, the gears mostly "ride" on the bucket wheel and, as well as matching the motor speed to the bucket-wheel speed, have the task of directing the torque safely to the supporting structure.

The motor is directly mounted on the torque support of the gear. The active forces on the bucket wheel from the swivel motion have to be taken up by the gear housing.

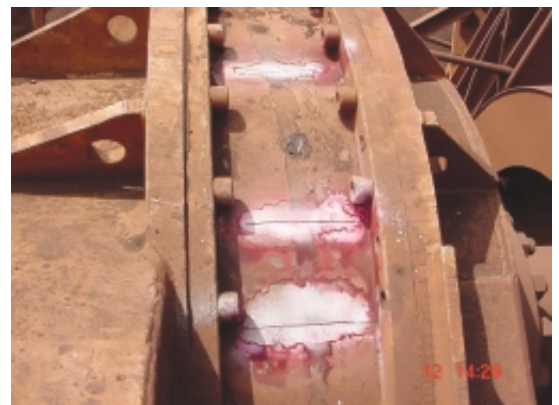
The figure on the left shows the installation of a torque measurement location on the bucket-wheel shaft in the Brazilian rain-forest. Despite extreme iron ore contamination, strain gages were carefully mounted and the mounting of a telemetry for the transmission of non-contact measured values including the Drive-Analysator® continued until late in the night. The measurement cables were then fed into the driver's cab and connected to the notebook computer for

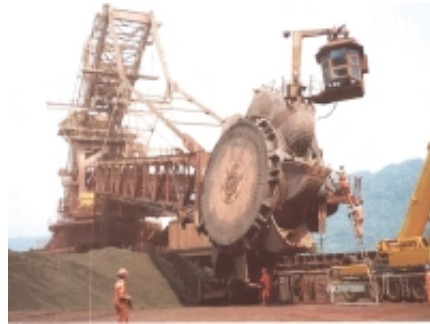
Figure 1: Mounting the replacement gear on the Brazilian bucket-wheel excavator

Before taking the measurements, it was agreed to mount a new gear in order to exclude the effects on the measurement signals of any preliminary damage to the gear. Figure 1 shows the mounting of the gear.

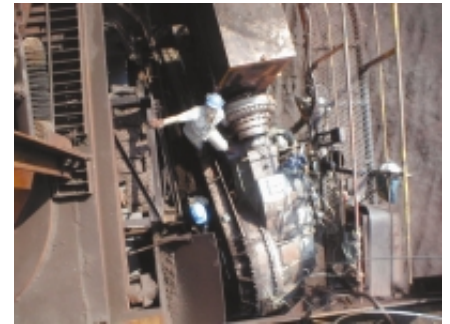
Figure 2: Calibration of the strain gages measurement location

evaluation. The torque measurement location itself was calibrated using a shunt resistor (Figure 2).

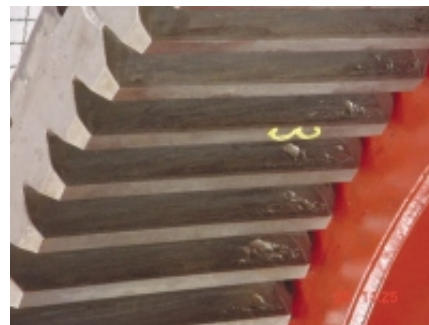
Figure 4: Unbalanced tooth damage on the internal gear

The disassembled bucket wheel gear was examined more closely. A red-white test on the housing revealed that there were further cracks in the area of the internal gear of the drive planetary stage. The planetary stage of the old gear was targeted for inspection as the next step. Unbalanced tooth damage on the internal gear of the planetary stage was a visible indicator of uneven lateral support in the planetary stage. Figure 5 shows an FEM model from the Bochum Ruhr University of how tilting can occur in bucket-wheel gears of this type as a result of the intrinsic weight and as a result of lateral forces during excavation. This tilting causes local overloads which, in Brazil, led not just to uneven lateral support, but also to housing cracks. In the past, Flender Service has gathered extensive experience, especially in bucket-wheel excavators for brown coal technology.

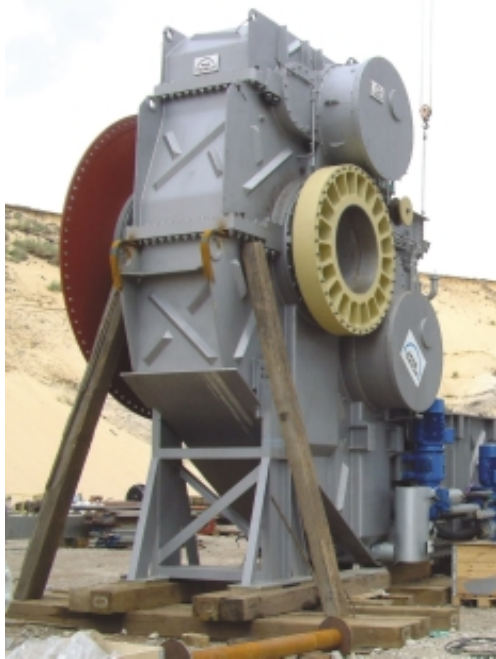
Figure 1: 80 ton gear on the main drive of the bucket wheel

The main drive of the bucket wheel of the large excavator being monitored has two drive motors, each with 1250 kW drive power and gear which weighs approx. 80 tons (Fig. 1). The gear reduction of each drive is realized by a bevel gear stage and subsequent planet gear stage with load distribution via a turning stage. This transfers the drive torque to the gear via four pinions and further to

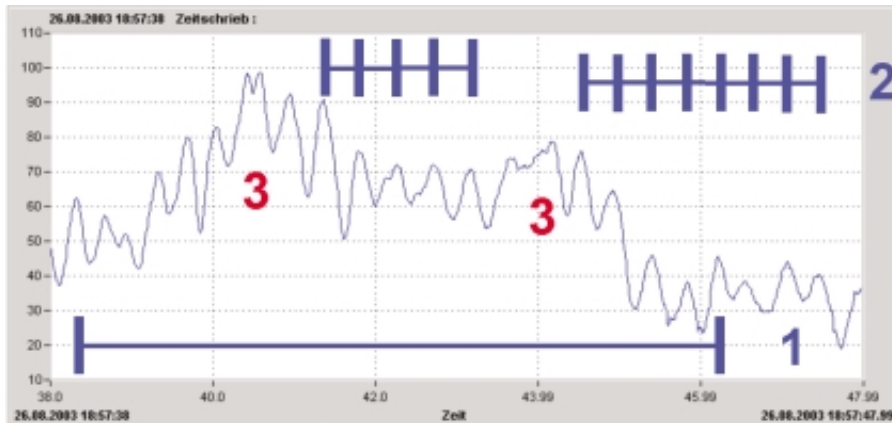
saved together with the curve of the load, speed and the displacements with prehistory and posthistory. This is carried out by an automatic event recording function. If necessary, the saved event can be examined more closely (Fig. 4).

Figure 4: (1) Period for a revolution of the bucket wheel
 (2) Periodic engagement of the buckets at negligible load
 (3) Transient drop in speed due to heavier torque loads

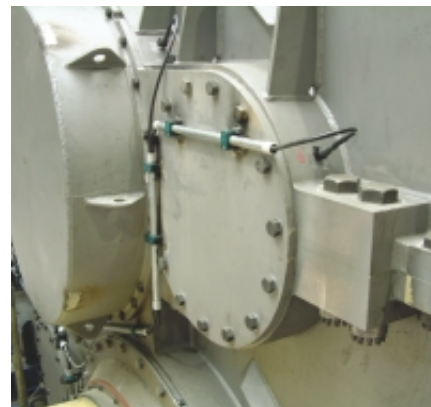
The main monitoring task on the very slow-speed roller bearing drive shaft (3.6 rpm) is the detection of critical wear limits. For this, two inductive displacement sensors were installed at less than 90 degrees on each of the two sides to directly monitor displacements due to changes in load and increased amounts of play.

Vibration transducers have been installed on the motors, gear input stages and intermediate shafts to monitor them.

Displacement Inductive displacement sensors on the hollow shaft

Vibration Accelerometers on rolling bearings

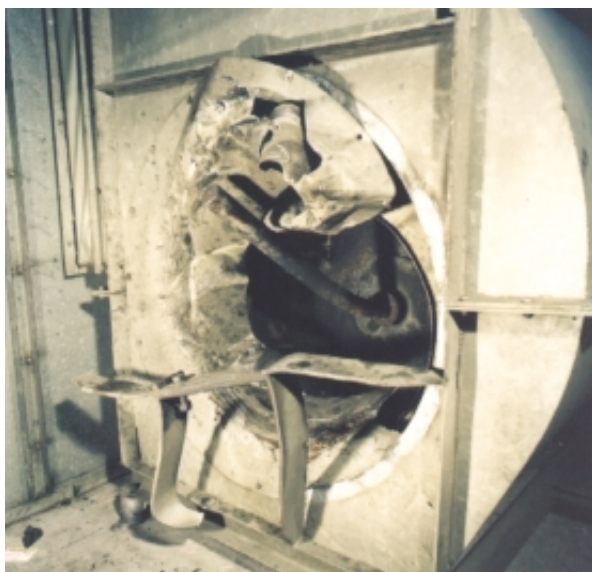
PRÜFTECHNIK was called in to evaluate damage on a supply air ventilator. The site was a scene of destruction and devastation.

Both pedestal bearings of the ventilator shaft had been torn off and hurled away. The 80 mm thick shaft was bent by approx. 30 degrees on both sides of the impeller. The impeller itself had run into the left and right suction cones, completely destroying them and was itself badly dented. All fan belts were torn – in short, this aggregate was a total write-off. What had happened?

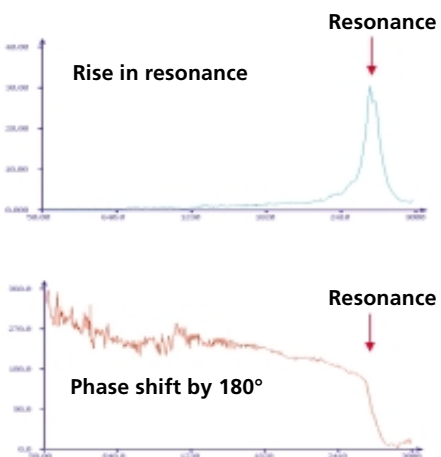
Figure 2

An important clue was the evidence from the operator who said the damage had occurred during the startup of the ventilator. As a ventilator of the same type was in operation nearby, it was possible to record a so-called Bode diagram or run up curve. This measurement records the amplitude of the rotational frequency vibrations (i.e. the part of the vibration caused by imbalance) as a function of the speed. It revealed a trend that indicated the crucial circumstantial evidence for the reconstruction of the damage progression (Fig. 1, right). At approx. 1130 rpm, and thus below the operating speed of 1300 rpm, a sudden rise in the rotational frequency vibration amplitude to more than 80 mm/s (!) appeared which then abruptly fell again above this critical speed. Consequently, the signal path corresponds precisely to the behavior of a rotor when passing

through its 1st flexing intrinsic vibration (Fig. 2). In addition to the distinctive rise in the rotational frequency vibrations, the phase rotation of 180° is especially typical.

Bode diagram / Startup curve

It was clear from this that only a rotor resonance could have been the underlying cause of the damage. However, the actual cause could have been increased imbalance of the impeller that could still have been absolutely permissible at the operational speed, but caused too large a vibration excitation when passing through the resonance point.

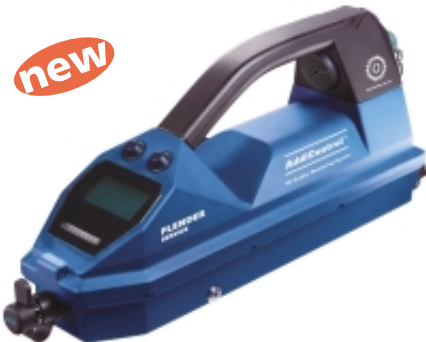
AddiControl® for analysis of oil qualities

Flender Service first introduced the AddiControl® to the general public at the 14th. International tribology conference in January 2004. The smell of the oil is measured to analyse the type of gear oil which is used, whether prohibited mixtures of oils are present or whether the additives are still OK. ■

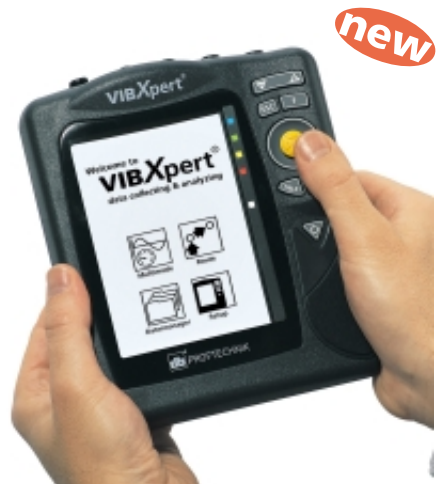
VIBXPERT® – new FFT data collector & signal analyzer

The new 2-channel analyzer was introduced at the Hanover tradefair. Information is also available on the Internet under: www.pruftechnik.com. ■
